# Lower Merrimack River Continuity Assessment

## Project Overview

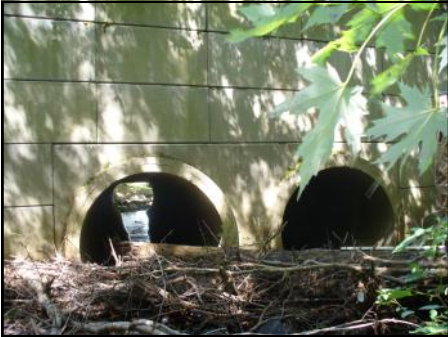
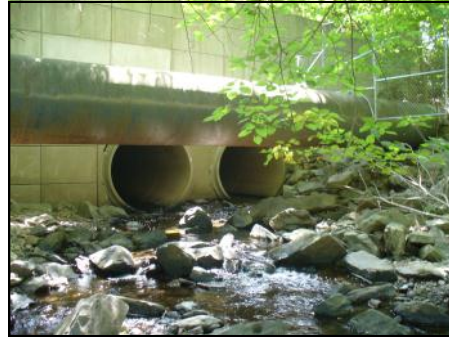
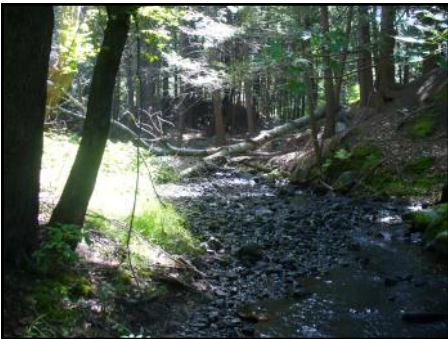
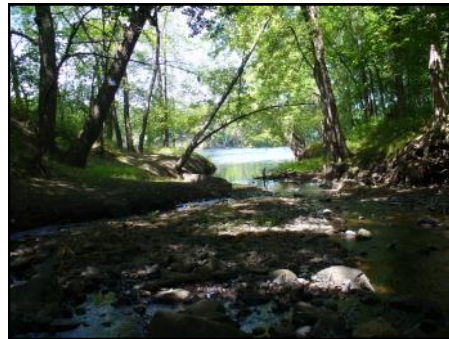
**NRPC ID—H50**    **Road Crossing—Radcliffe Drive**    **Latitude—42.45163**    **Longitude—71.26165**

**Geomorphic Compatibility—Mostly Compatible**

**Aquatic Organism Passage—No AOP except adult salmonids**

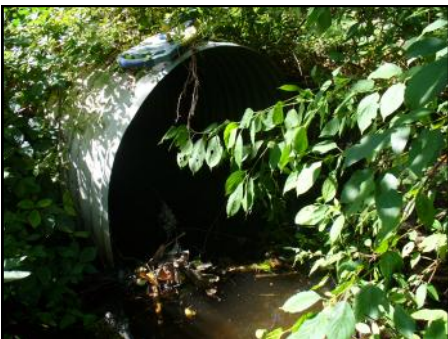
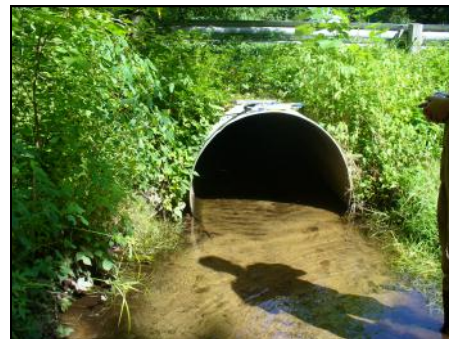
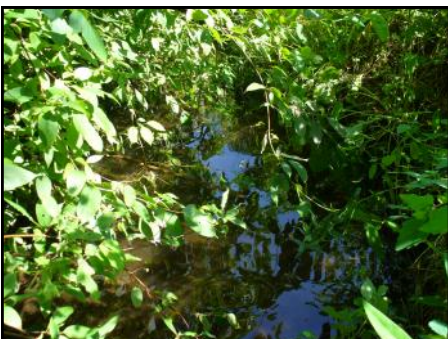
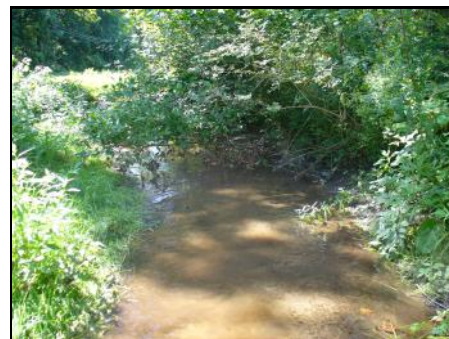
**NRPC ID—H12**    **Road Crossing—Kenyon Street**    **Latitude—42.46268**    **Longitude—71.26542**

**Geomorphic Compatibility—Mostly Incompatible**

**Aquatic Organism Passage—Reduced AOP**

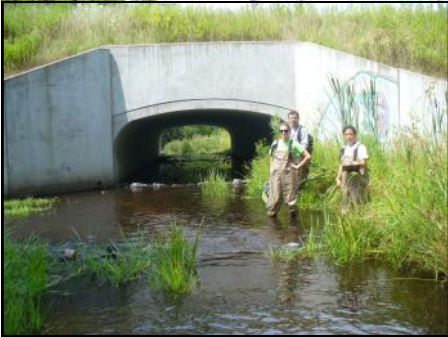
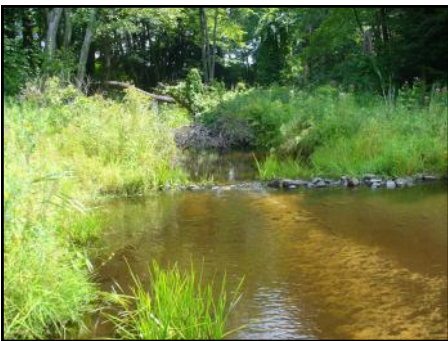
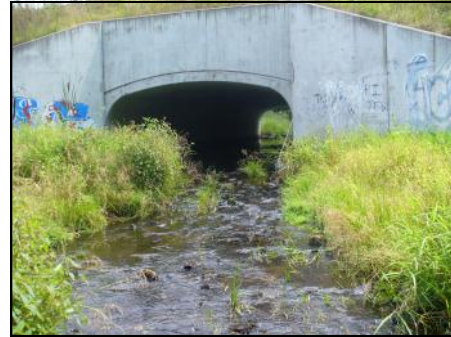
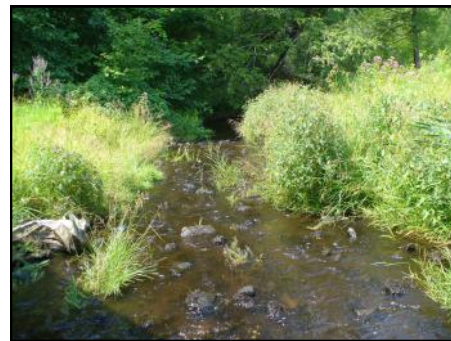
**NRPC ID—L5**    **Road Crossing—**Albuquerque Ave (north end)    **Latitude—**42.52508    **Longitude—**71.27142

**Geomorphic Compatibility—**Fully Compatible

**Aquatic Organism Passage—**Full AOP

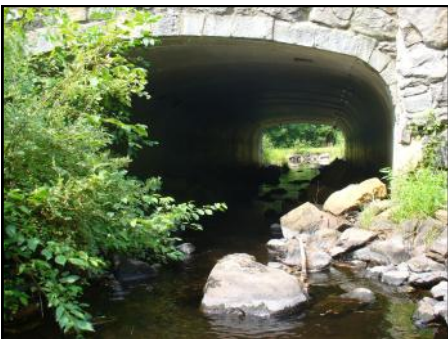
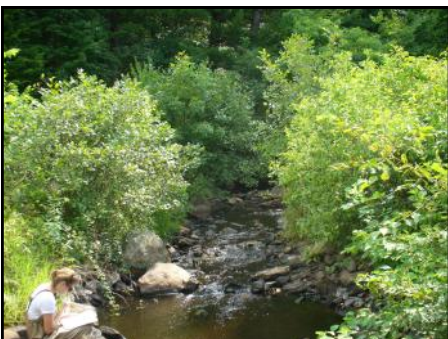
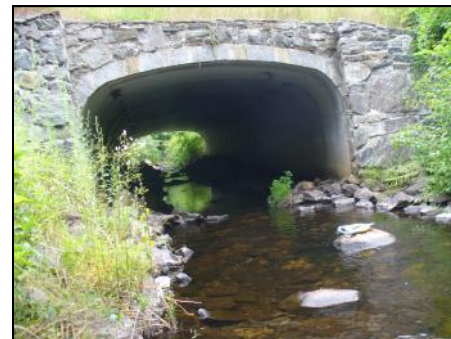
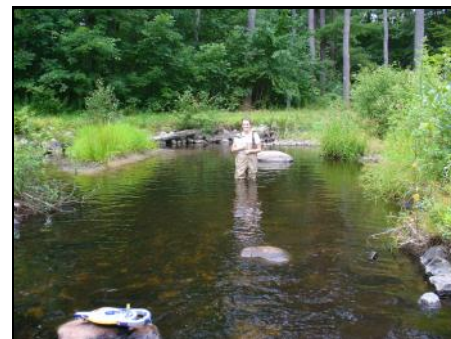
**NRPC ID—L8**    **Road Crossing—**Rt. 3A (near Pinecrest Rd)    **Latitude—**42.50088    **Longitude—**71.28258

**Geomorphic Compatibility—**Fully Compatible

**Aquatic Organism Passage—**Reduced AOP

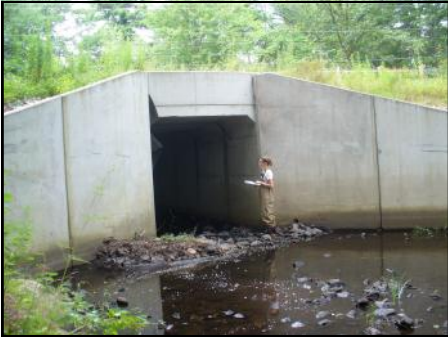
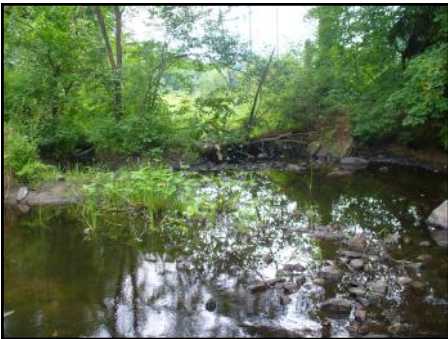
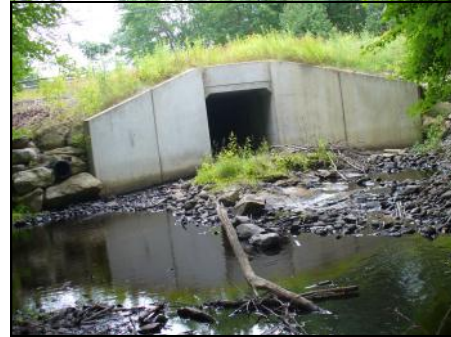
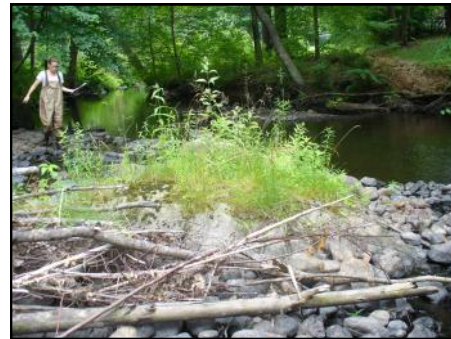
**NRPC ID—L18**    **Road Crossing—Brickyard Drive**    **Latitude—42.50083**    **Longitude—71.28034**

**Geomorphic Compatibility—Partially Compatible**

**Aquatic Organism Passage—Reduced AOP**

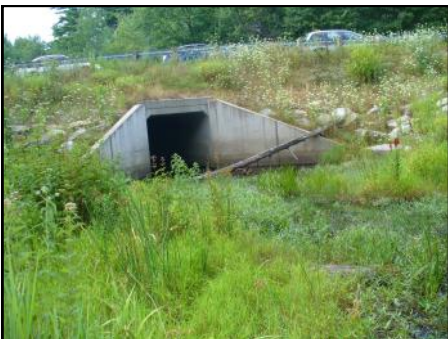
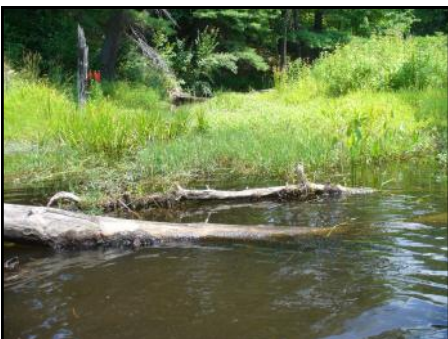
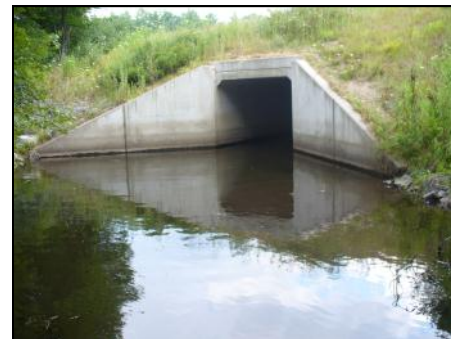
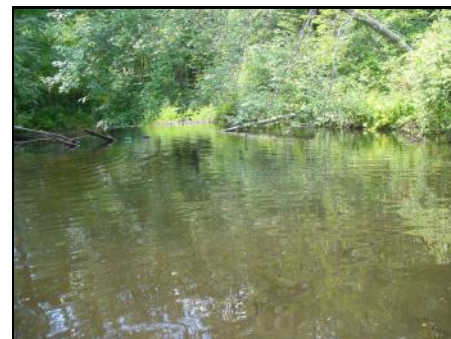
**NRPC ID—L4**    **Road Crossing—Albuquerque Ave (near Pinecrest Rd)**    **Latitude—42.50316**    **Longitude—71.26591**

**Geomorphic Compatibility—Mostly Compatible**

**Aquatic Organism Passage—Reduced AOP**

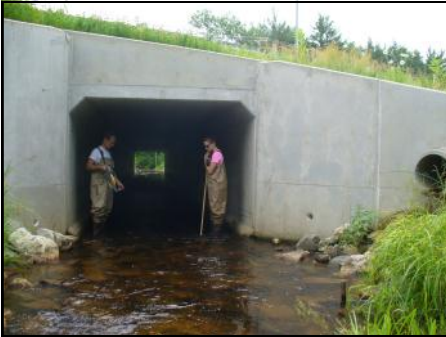
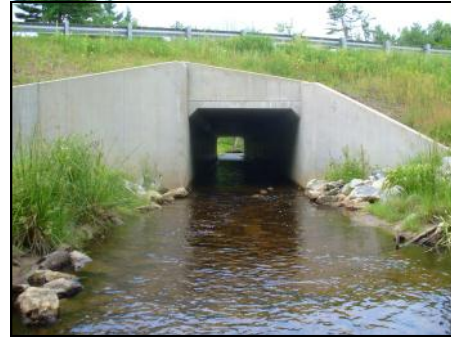
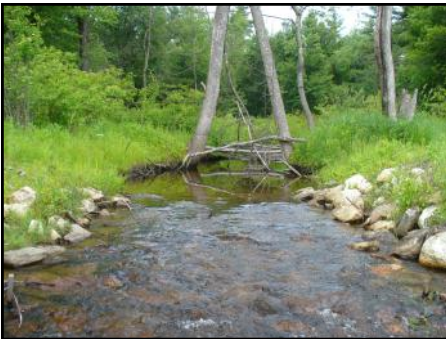
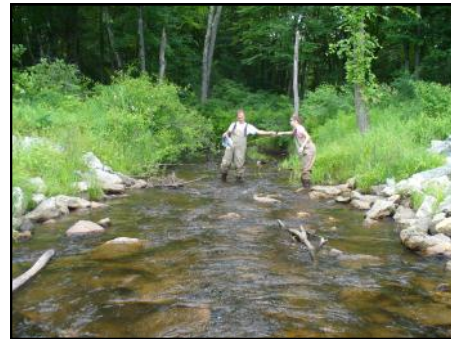
**NRPC ID—M25**    **Road Crossing—Daniel Webster Hwy**    **Latitude—42.91004**    **Longitude—71.45843**

**Geomorphic Compatibility—Fully Compatible**

**Aquatic Organism Passage—Reduced AOP**

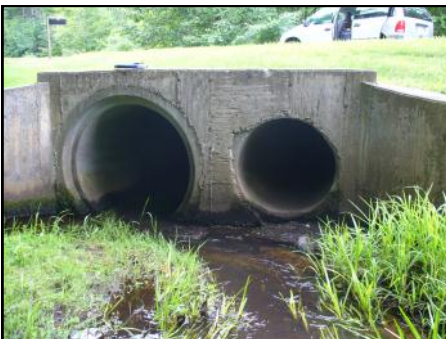
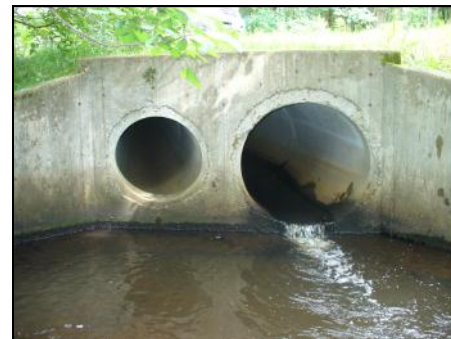
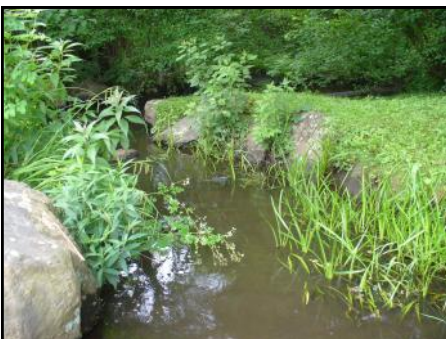
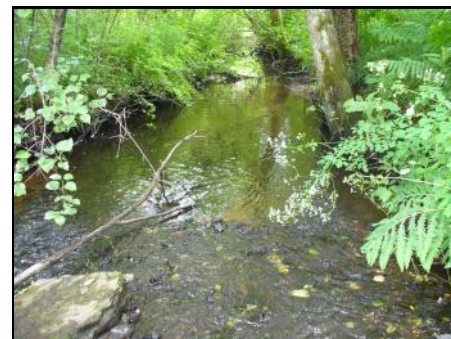
**NRPC ID—M9**    **Road Crossing—Cramer Hill Road**    **Latitude—42.48546**    **Longitude—71.33297**

**Geomorphic Compatibility—Mostly Incompatible**

**Aquatic Organism Passage—No AOP including adult salmonids**

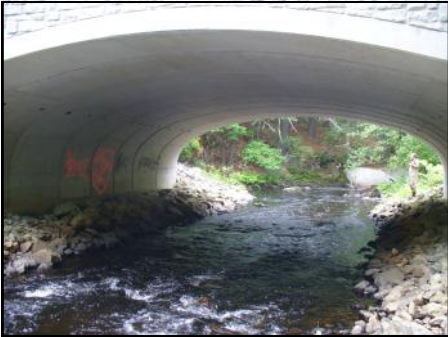
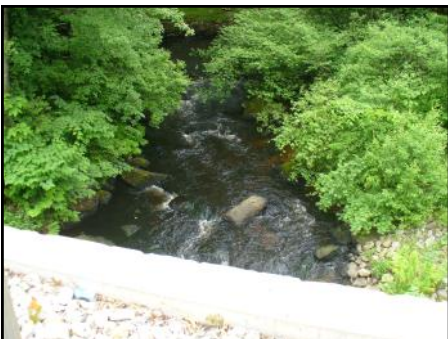
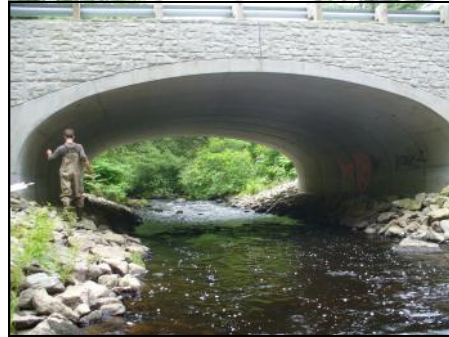
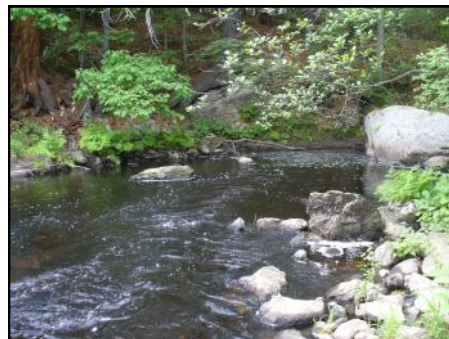
**NRPC ID—M27    Road Crossing—Bedford Rd    Latitude—42.89336    Longitude—71.51428**

**Geomorphic Compatibility—Fully Compatible**

**Aquatic Organism Passage—Full AOP**

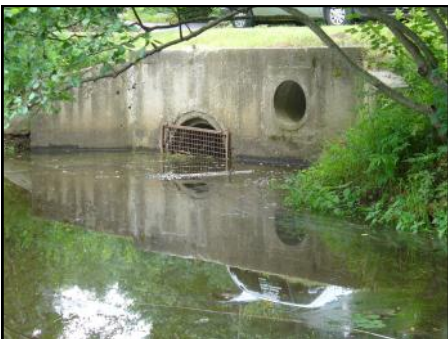
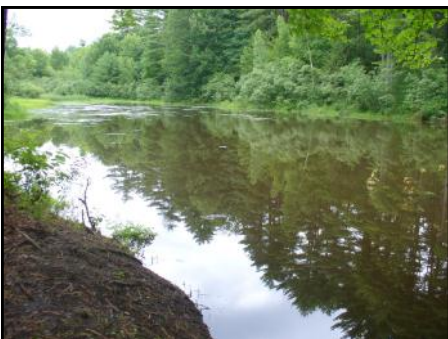
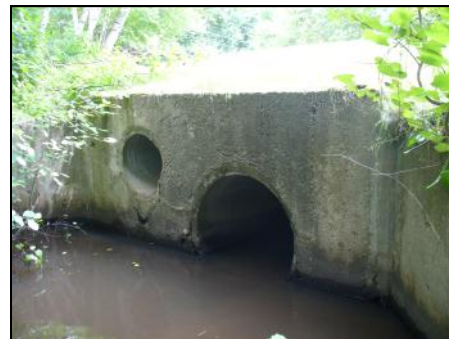
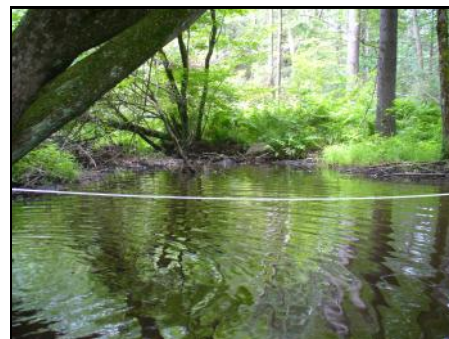
**NRPC ID—M8    Road Crossing—Landau Way    Latitude—42.49019    Longitude—71.33249**

**Geomorphic Compatibility—Mostly Compatible**

**Aquatic Organism Passage—Reduced AOP**

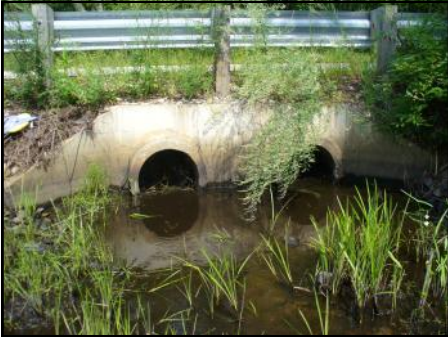
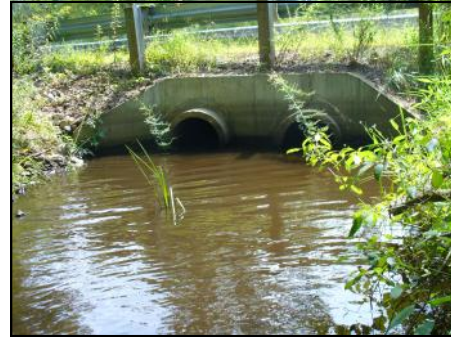
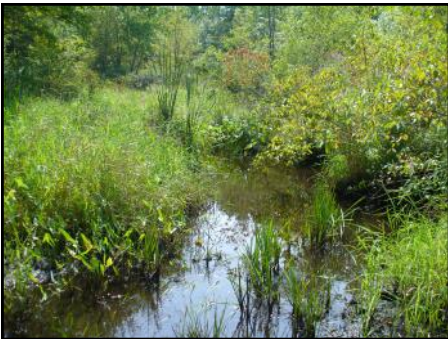
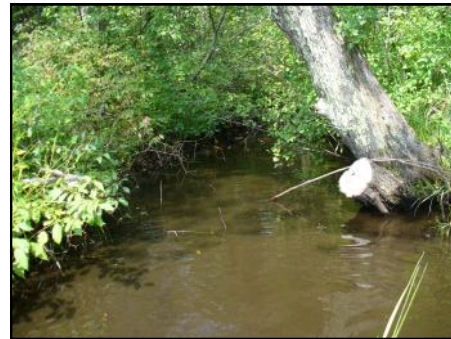
**NRPC ID—N7**    **Road Crossing—**Gilson Road    **Latitude—**42.43036    **Longitude—**71.31366

**Geomorphic Compatibility—**Mostly Compatible

**Aquatic Organism Passage—**Reduced AOP

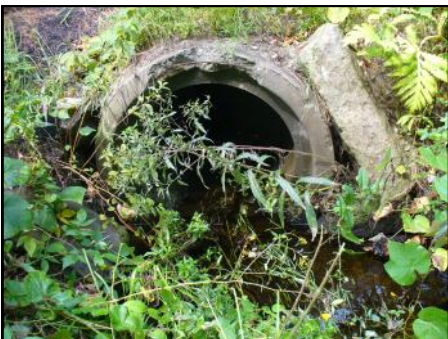
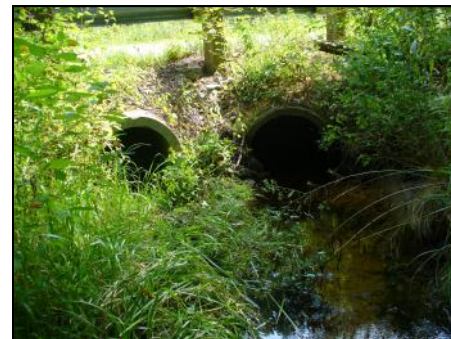
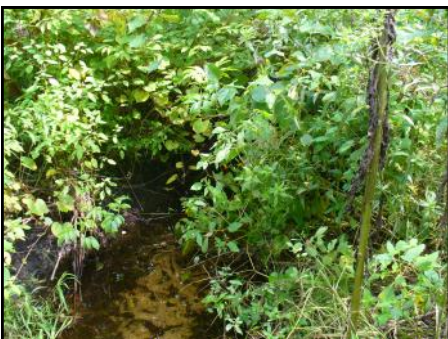
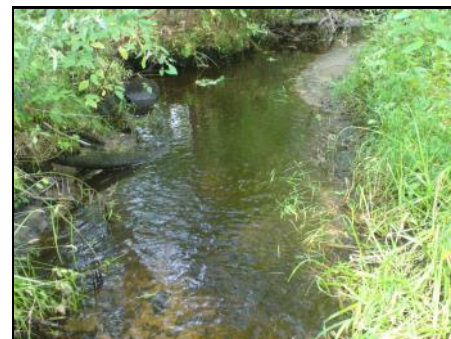
**NRPC ID—N13**    **Road Crossing—**Gilson Rd (near Musket Dr)    **Latitude—**42.43065    **Longitude—**71.30576

**Geomorphic Compatibility—**Partially Compatible

**Aquatic Organism Passage—**Reduced AOP
