# Lower Merrimack River Continuity Assessment

## Project Overview

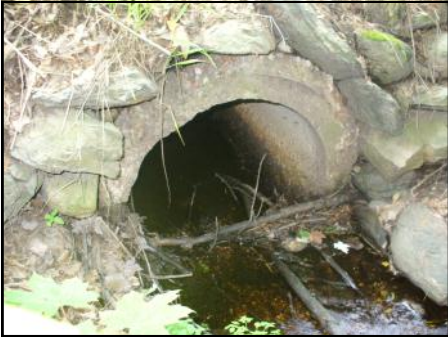
Culvert Inlet looking Downstream

**NRPC ID—M6**    **Road Crossing—Thornton Rd**    **Latitude—42.80684**    **Longitude—71.50669**

**Geomorphic Compatibility**—analysis not available because culvert is located in public water supply (limited access)

**Aquatic Organism Passage**—analysis not available because culvert is located in public water supply (limited access)

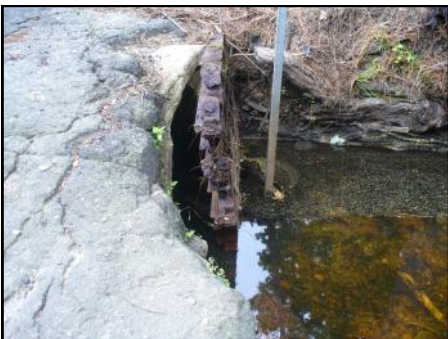
Culvert Inlet looking Downstream

**NRPC ID—M22**    **Road Crossing—Thorton Road**    **Latitude—42.80462**    **Longitude—71.51211**

**Geomorphic Compatibility**—analysis not available because culvert is located in public water supply (limited access)

**Aquatic Organism Passage**—analysis not available because culvert is located in public water supply (limited access)
